Inspection Report

100 Penny Lane
Hendersonville, TN 37075

Prepared for: Ellen Rigby

Prepared by: Complete Home Inspections, Inc.
9075 Richmond Way
Gallatin, TN 37066

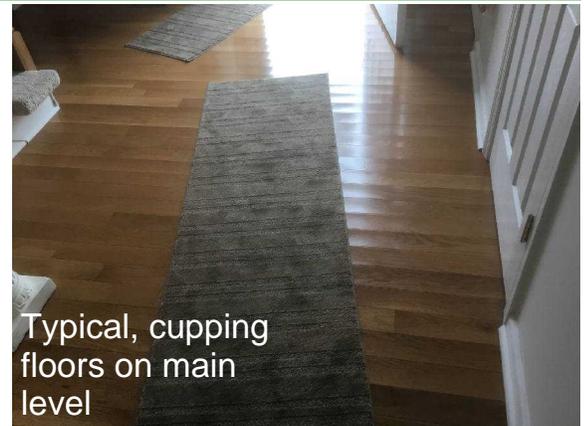
The hardwood flooring on the main level is badly cupped. Typically this is an indication of moisture from the under-floor area causing the bottom side of the wood to expand while the finished side of the floor remains in its original size due to dehumidification equipment. The cause for this varies greatly and is beyond the scope of a visual home inspection. If this is an area of concern, recommend further review of the under-floor area by a licensed contractor. Check to see if the hardwood flooring can be made to lay flat if the crawlspace area is dried out.

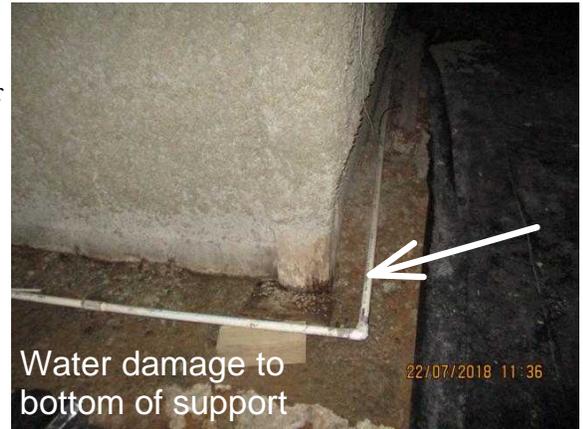
5. Structure: One of the bearing supports on the far side opposite the entrance is starting to rot out at the bottom. Recommend that this area be further reviewed/repaired by a licensed contractor.

Action Item Structure: One of the bearing supports on the far side opposite the entrance is starting to rot out at the bottom. Recommend that this area be further reviewed/repaired by a licensed contractor.

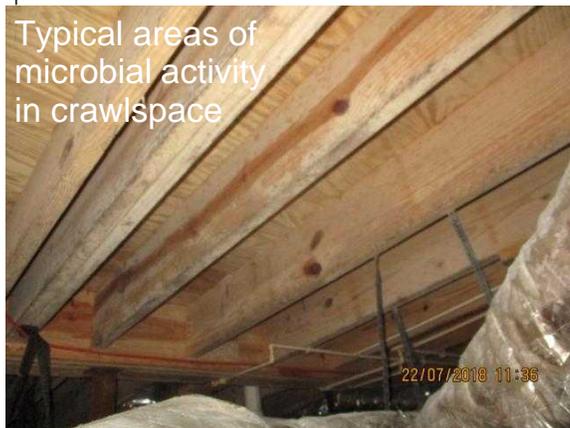
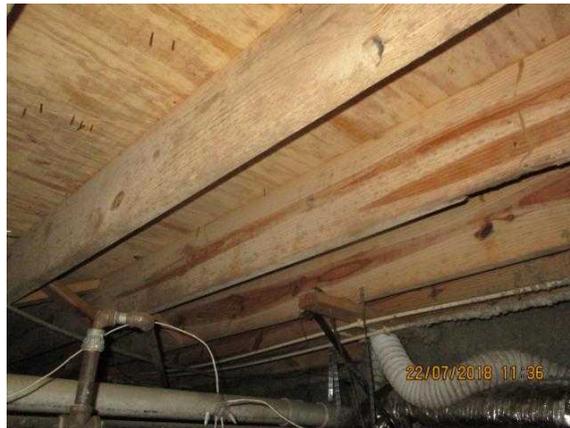
6. Microbial Activity: Microbial activity has been observed in various areas of the crawlspace area. This appears to be consistent with properties of this age. Everyone's susceptibility to mold-like particles varies. If this is an area of concern, seek the advice and services of a licensed professional in the appropriate trade.

Action Item Microbial Activity: Microbial activity has been observed in various areas of the crawlspace area. This appears to be consistent with properties of this age. Everyone's susceptibility to mold-like particles varies. If this is an area of concern, seek the advice and services of a licensed professional in the appropriate trade.

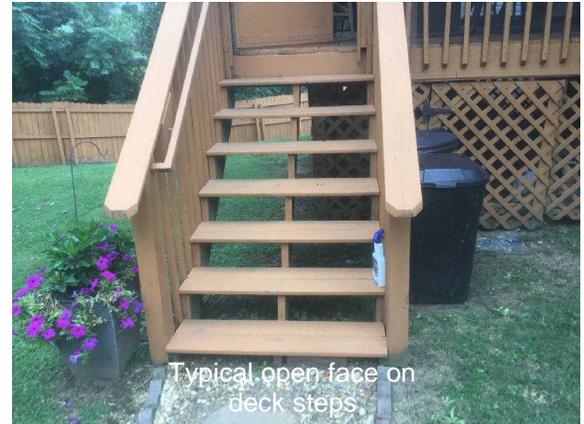
1. Wood Steps & Stoops: Although it may have been an acceptable building practice at the time the property was constructed, the open face between the treads on the deck steps no longer conform to current industry safety standards. As a matter of function and safety, consider making upgrades.

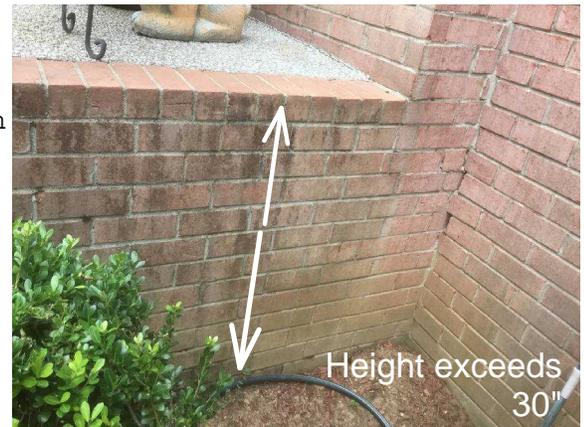
2. Guards - Porch: Guardrails are not present at the right side of the front stoop. This may not have been a requirement at the time the property was constructed. For your own protection and reduction in liability recommend installing guardrails that meet current standards as the height between the decking and the ground exceeds 30 inches.

General Notes Guards - Porch: Guardrails are not present at the right side of the front stoop. This may not have been a requirement at the time the property was constructed. For your own protection and reduction in liability recommend installing guardrails that meet current standards as the height between the decking and the ground exceeds 30 inches.

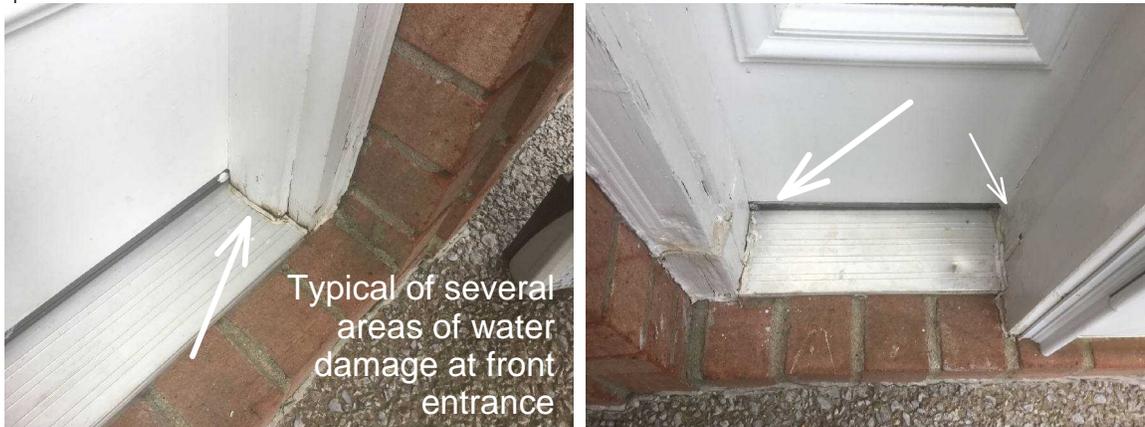
5. Entry Door Trim: Water damage has been observed on the frame at the entrance doors. As a component of ongoing maintenance and to prevent further damage, recommended that these areas be repaired.

General Notes Entry Door Trim: Water damage has been observed on the frame at the entrance doors. As a component of ongoing maintenance and to prevent further damage, recommended that these areas be repaired.

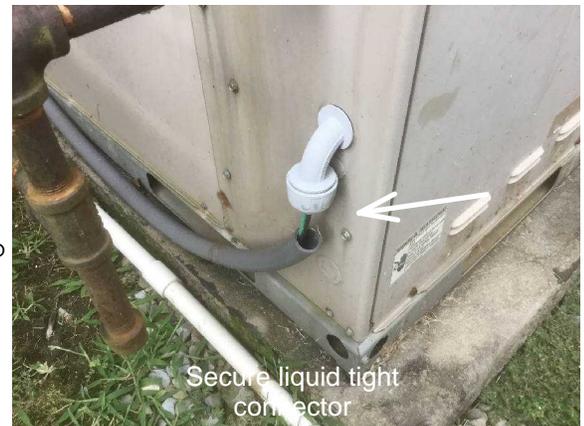
8. Additional Notes: As part of ongoing maintenance, recommend securing disconnected liquid tight connection on the package unit.

- General Notes Additional Notes: As part of ongoing maintenance, recommend securing disconnected liquid tight connection on the package unit.

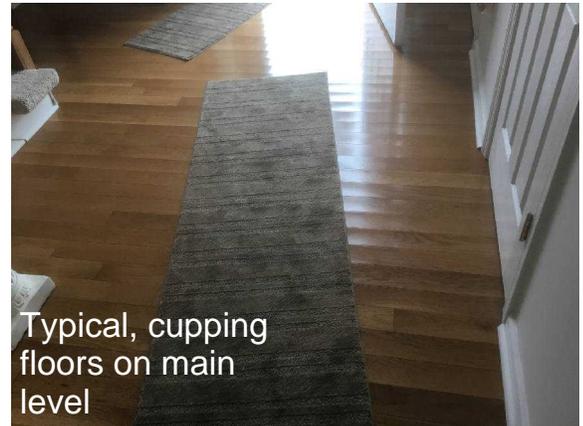
The hardwood flooring on the main level is badly cupped. Typically this is an indication of moisture from the under-floor area causing the bottom side of the wood to expand while the finished side of the floor remains in its original size due to dehumidification equipment. The cause for this varies greatly and is beyond the scope of a visual home inspection. If this is an area of concern, recommend further review of the under-floor area by a licensed contractor. Check to see if the hardwood flooring can be made to lay flat if the crawlspace area is dried out.

ACTION ITEM ===
The hardwood flooring on the main level is badly cupped. Typically this is an indication of moisture from the under-floor area causing the bottom side of the wood to expand while the finished side of the floor remains in its original size due to dehumidification equipment. The cause for this varies greatly and is beyond the scope of a visual home inspection. If this is an area of concern, recommend further review of the under-floor area by a licensed contractor. Check to see if the hardwood flooring can be made to lay flat if the crawlspace area is dried out.

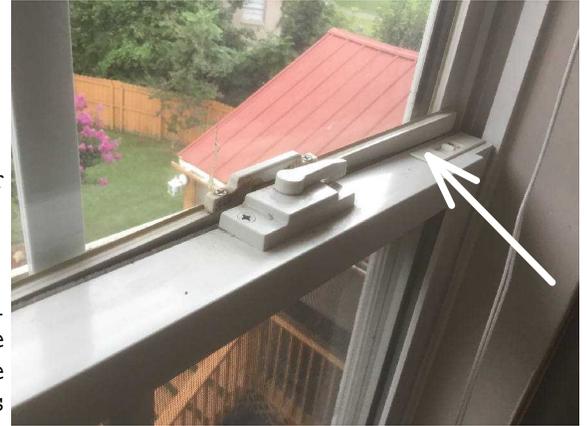
14. Windows: The bottom of the left side window in the master bedroom is damaged. This will prevent the window from latching. If this is an area of concern, recommend repair.

- General Notes Windows: The bottom of the left side window in the master bedroom is damaged. This will prevent the window from latching. If this is an area of concern, recommend repair.

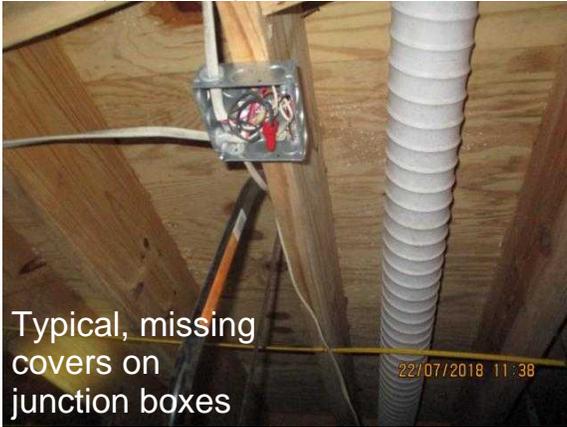
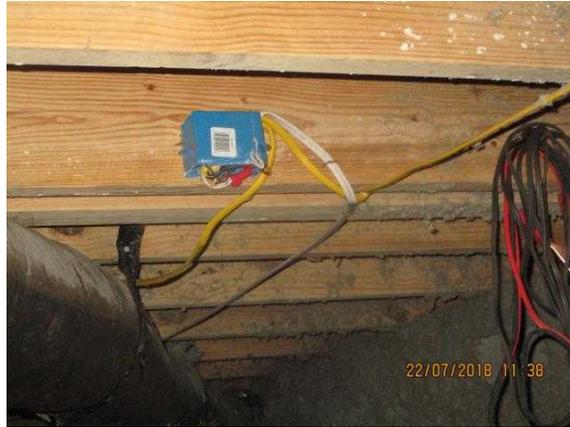
20. Electrical: Install missing cover plates on all junction boxes so as to conform to industry standards.

General Notes Electrical: Install missing cover plates on all junction boxes so as to conform to industry standards.
